# A Study of the Damaged Frescoes and Restoration in Zhulin Temple in Lingbao

**Abstract:** This data paper mainly elaborates the preservation of frescoes in Zhulin Temple in Lingbao, where a detailed investigation into the deterioration was carried out on May 2020 by using X-ray diffraction (XRD), micro confocal Raman spectrometer (Raman), and scanning electron microscopy- energy dispersive spectrometer (SEM-EDS) to detect and analyze the pigments. After the field protection and experiments for repairing have been conducted for ridding the damages, the dataset obtained is as follows: (1) high resolution photographs of the frescoes and CAD drawing of the mural's location; (2) the statistical table of the pictures under investigation; (3) the area statistics of the damaged frescoes; (4) the results of pigment test. Meanwhile, this paper analyzes the preservation of frescoes in Zhulin Temple, the results of investigation and pigment detection, and then summarizes the influence of environment on mural painting. Finally the on-site protection and restoration have been carried out for different damages. The dataset, consisting of 39 data files with a data size of 232 MB (compressed int

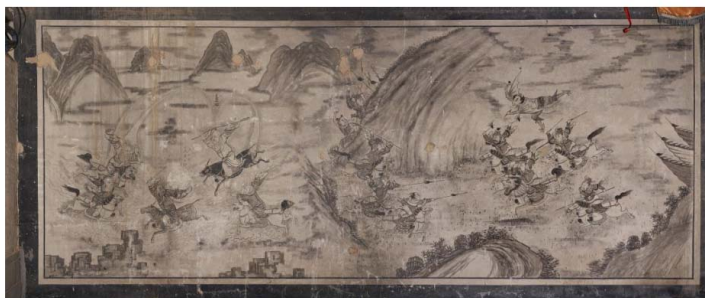
For long years out of repair, the frescoes are seriously damaged (Figure 1). In order to repair and restore frescoes as they are, it is necessary to have this dataset completed based on the investigation of the frescoes in terms of the situation, causes, components and scheme.

**Figure 1** Water stain, pigment layer and spot-like shedding in Jiuku Hall of Zhulin Temple in Lingbao, Sanmenxia of China (No.3)

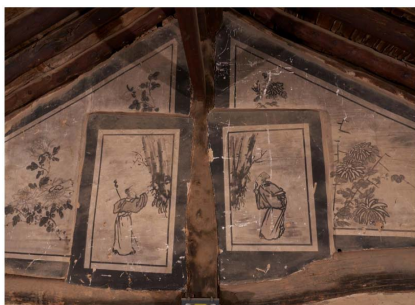
Peony, chrysanthemum flower and two characters are painted on the upper part of the eastern gable. Most coatings on the north side of the peony fall off and there are a lot of scratches on the mural (Figure 2). There are 15 characters in the lower part of the picture, among which 6 are riding horses, one riding a unicorn and 2 riding unnamed beasts. Each of them holds either a weapon out of the ordinary or a magic item, very much alike the scene in the war described in Creation of the Gods. There are long cracks from top to bottom in the middle of the mural, a lot of water stains, layer and point-like pigment shedding. For the mural is stuck to the newspaper, there are a lot of coating layer shedding in the lower part of the mural, pulverized pigment layer and dusty mural surface.

**Figure 2** Mural cracks on the upper part of the east gable (No.9)

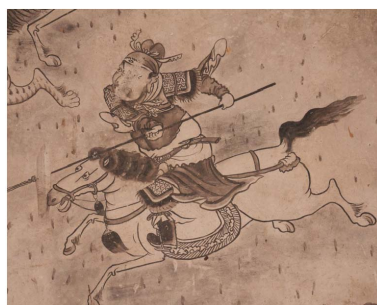
There are plum blossoms, lotus flowers and two figures painted on the gable at the upper part of the western wall. A large area of coating falls off the upper part of the lotus flower, and there are a lot of water and mud stains in the plum blossom. There are 14 figures in the mural at the lower part of the western wall, among which 12 are riding horses or mythical beasts, one has wings, and the other holds a gankun circle. Everyone holds weapons or a magic item in their hands, very much alike the scene in the war described in Creation of the Gods. In the lower part of the mural are cracks, a large number of water stains and mud stains from top to bottom, many places where the coating and pigment layer fall off a lot, layer and point-like pigment shedding (Figure 3), pulverized pigment layer, scratches and

**Figure 3** Excerpt from mural on the west side of the north wall-pigment layer shedding (No.37)

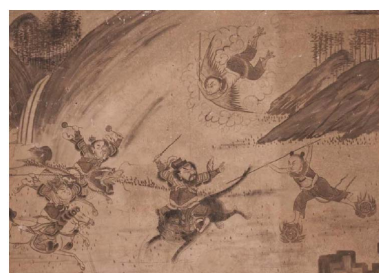
There are five figures in the mural painting on the west side of the north wall, with three riding a god beast, one stepping on a hot wheel and one born with long wing who flies in the sky. Each person holds a weapon or a magic item in their hands, very much alike the scene in the war described in Creation of the Gods. There are water stains running from top to bottom, pulverized pigment layer, dusty mural surface and a lot of pigment layer falling off the edge of mural painting (Figure 4).

**Figure 4** Excerpts from murals on the west side of the north wall-spot-like shedding and pulverization of pigment layer (No.22)

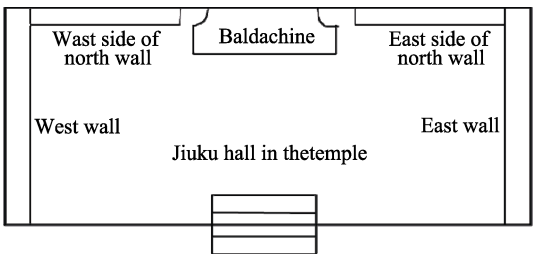
There are a total of CAD-made distribution maps of murals in temple, including the map of mural in Jiuku Hall (see Figure 5; No.2), location plans No.10, No.18 and No.25. The length and width of murals and their walls on the floor plan have been accurately marked.

Figure 5 Distribution map of the four walls (east wall, east side of north wall, west side of north wall and west wall) of Jiuku Hall in the Temple

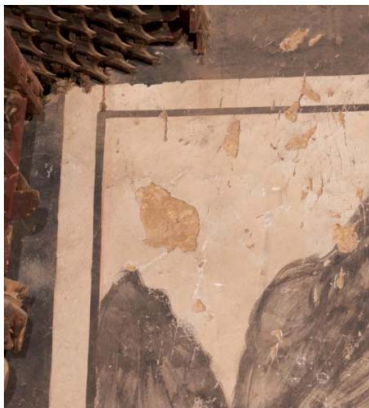
There are 32 pictures of damaged murals in total in this dataset (Figure 6, 7). The damages recorded in these photos include pigment layer crack and shedding, pulverization, dust-fall, point shedding, cracks, covering, man-made damage, hollowing, coating shedding, dissolution of alkali and salts, mud stains, water stains, repair marks, smoking, covering, scratches, scribbles, animals’ damage, etc.

Figure 6 Coating shedding (No.26 excerpt)

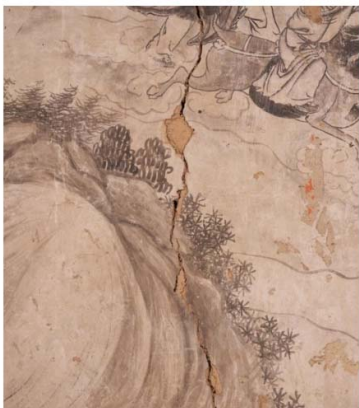
Figure 7 Crack (No.31)
